Detroit Warehouse Fire Claims Three Firefighters

Detroit Warehouse Fire Claims Three Firefighters (March 12, 1987)

Investigated by: J. Gordon Routley

**This is Report 003 of the Major Fires Investigation Project conducted
by TriData Corporation under contract EMW-88-C-2277 to the United
States Fire Administration, Federal Emergency Management Agency.**

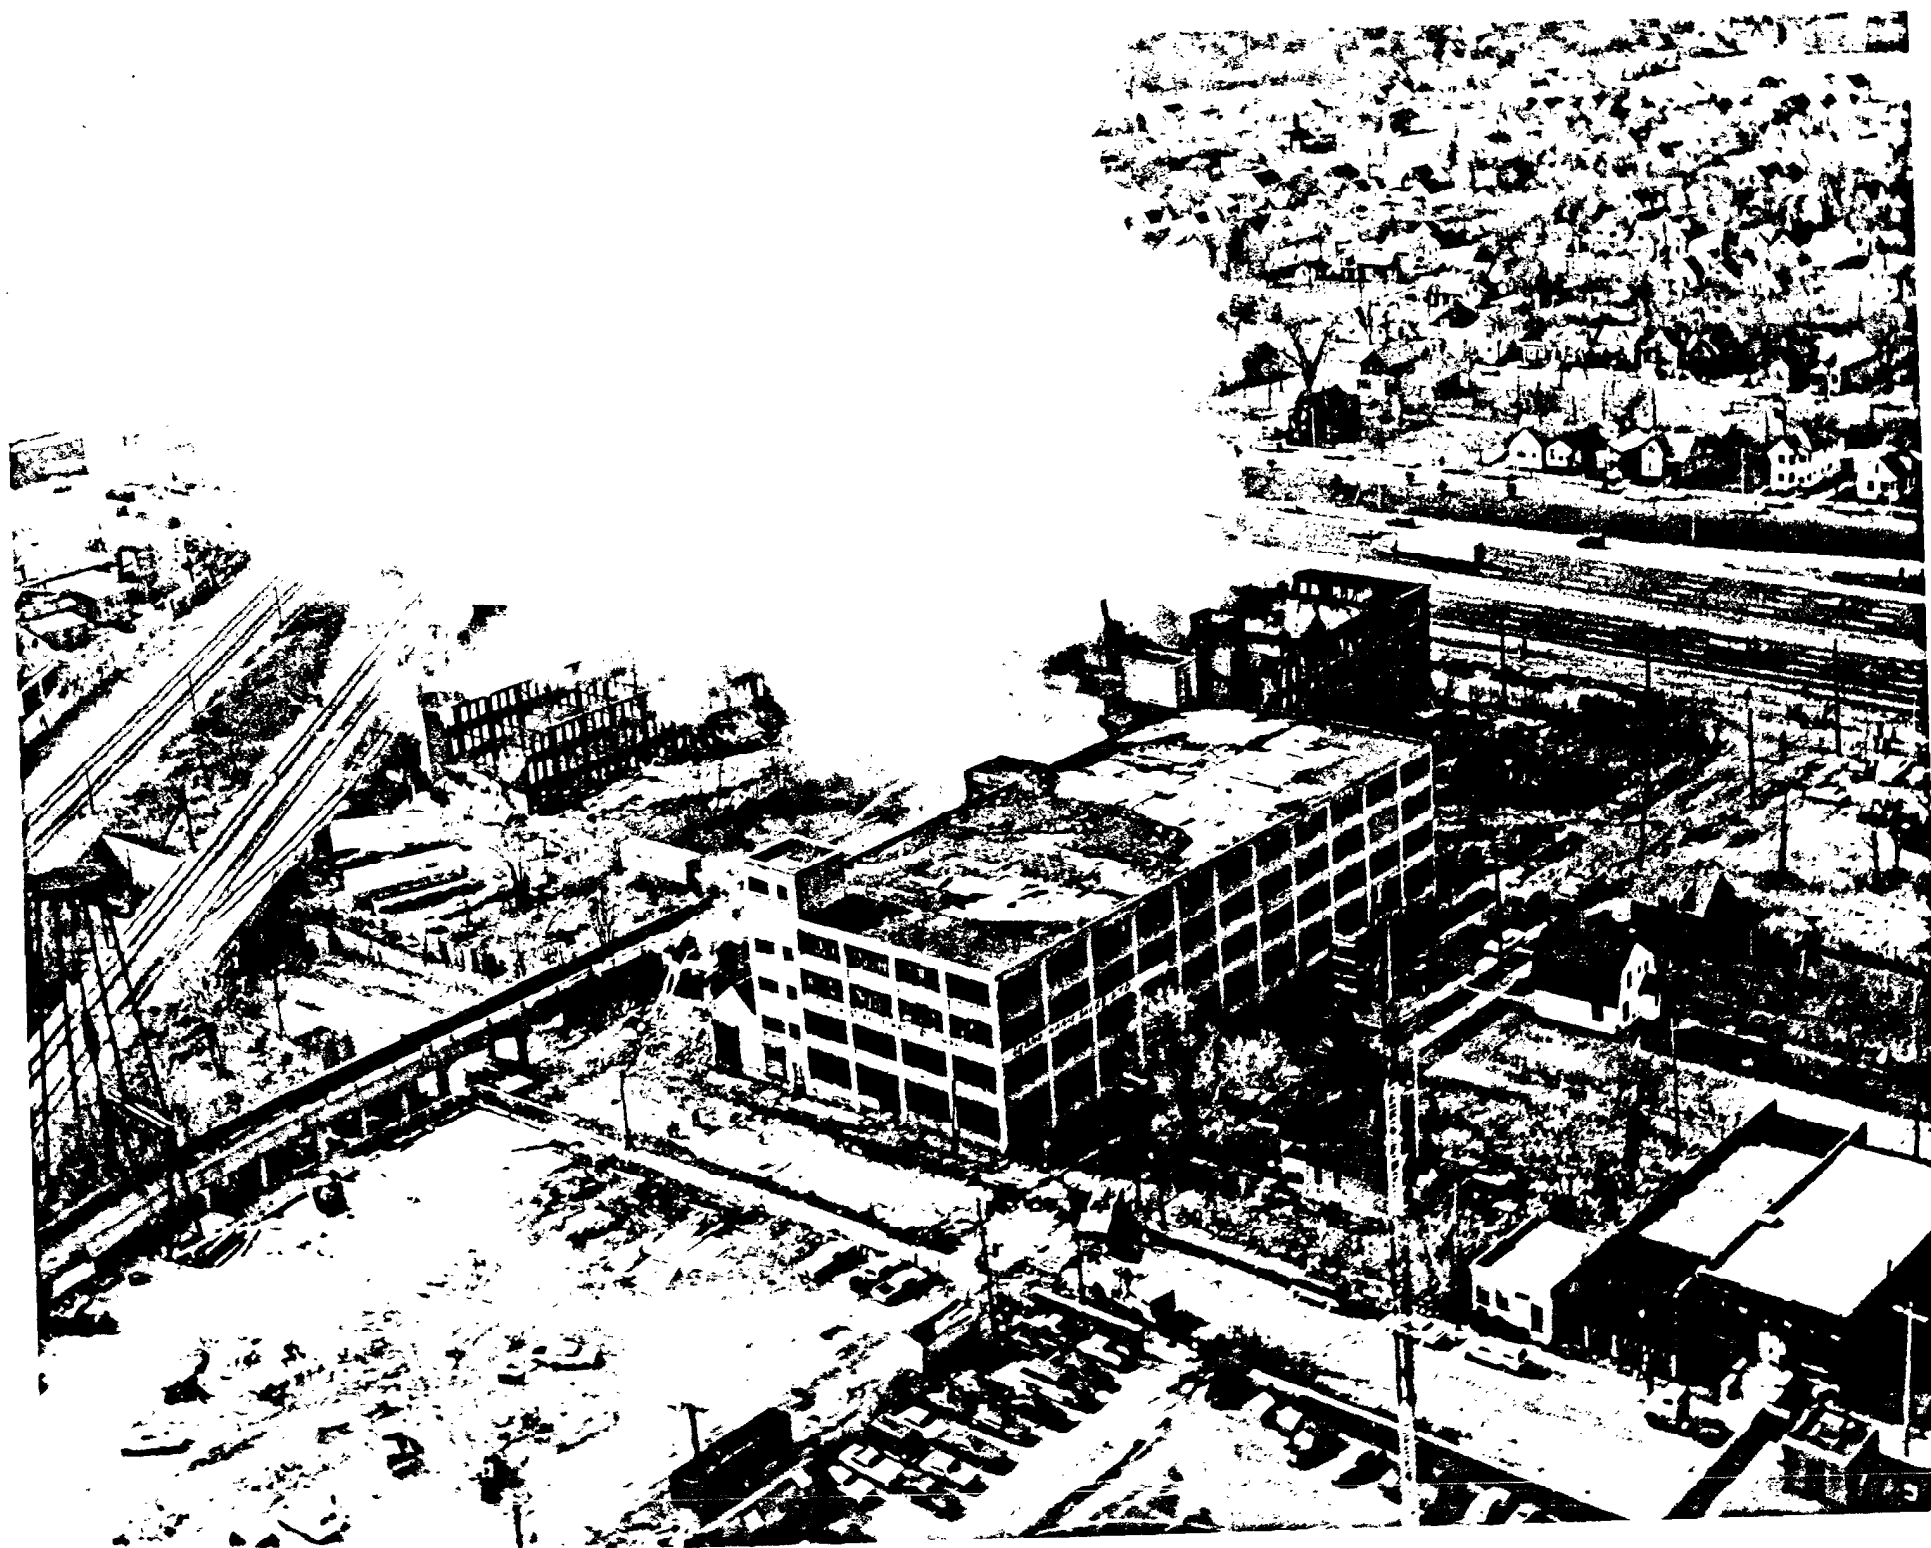
PHOTO 7: Fire in tires at ground level and fire spread on 2nd and 3rd floors.

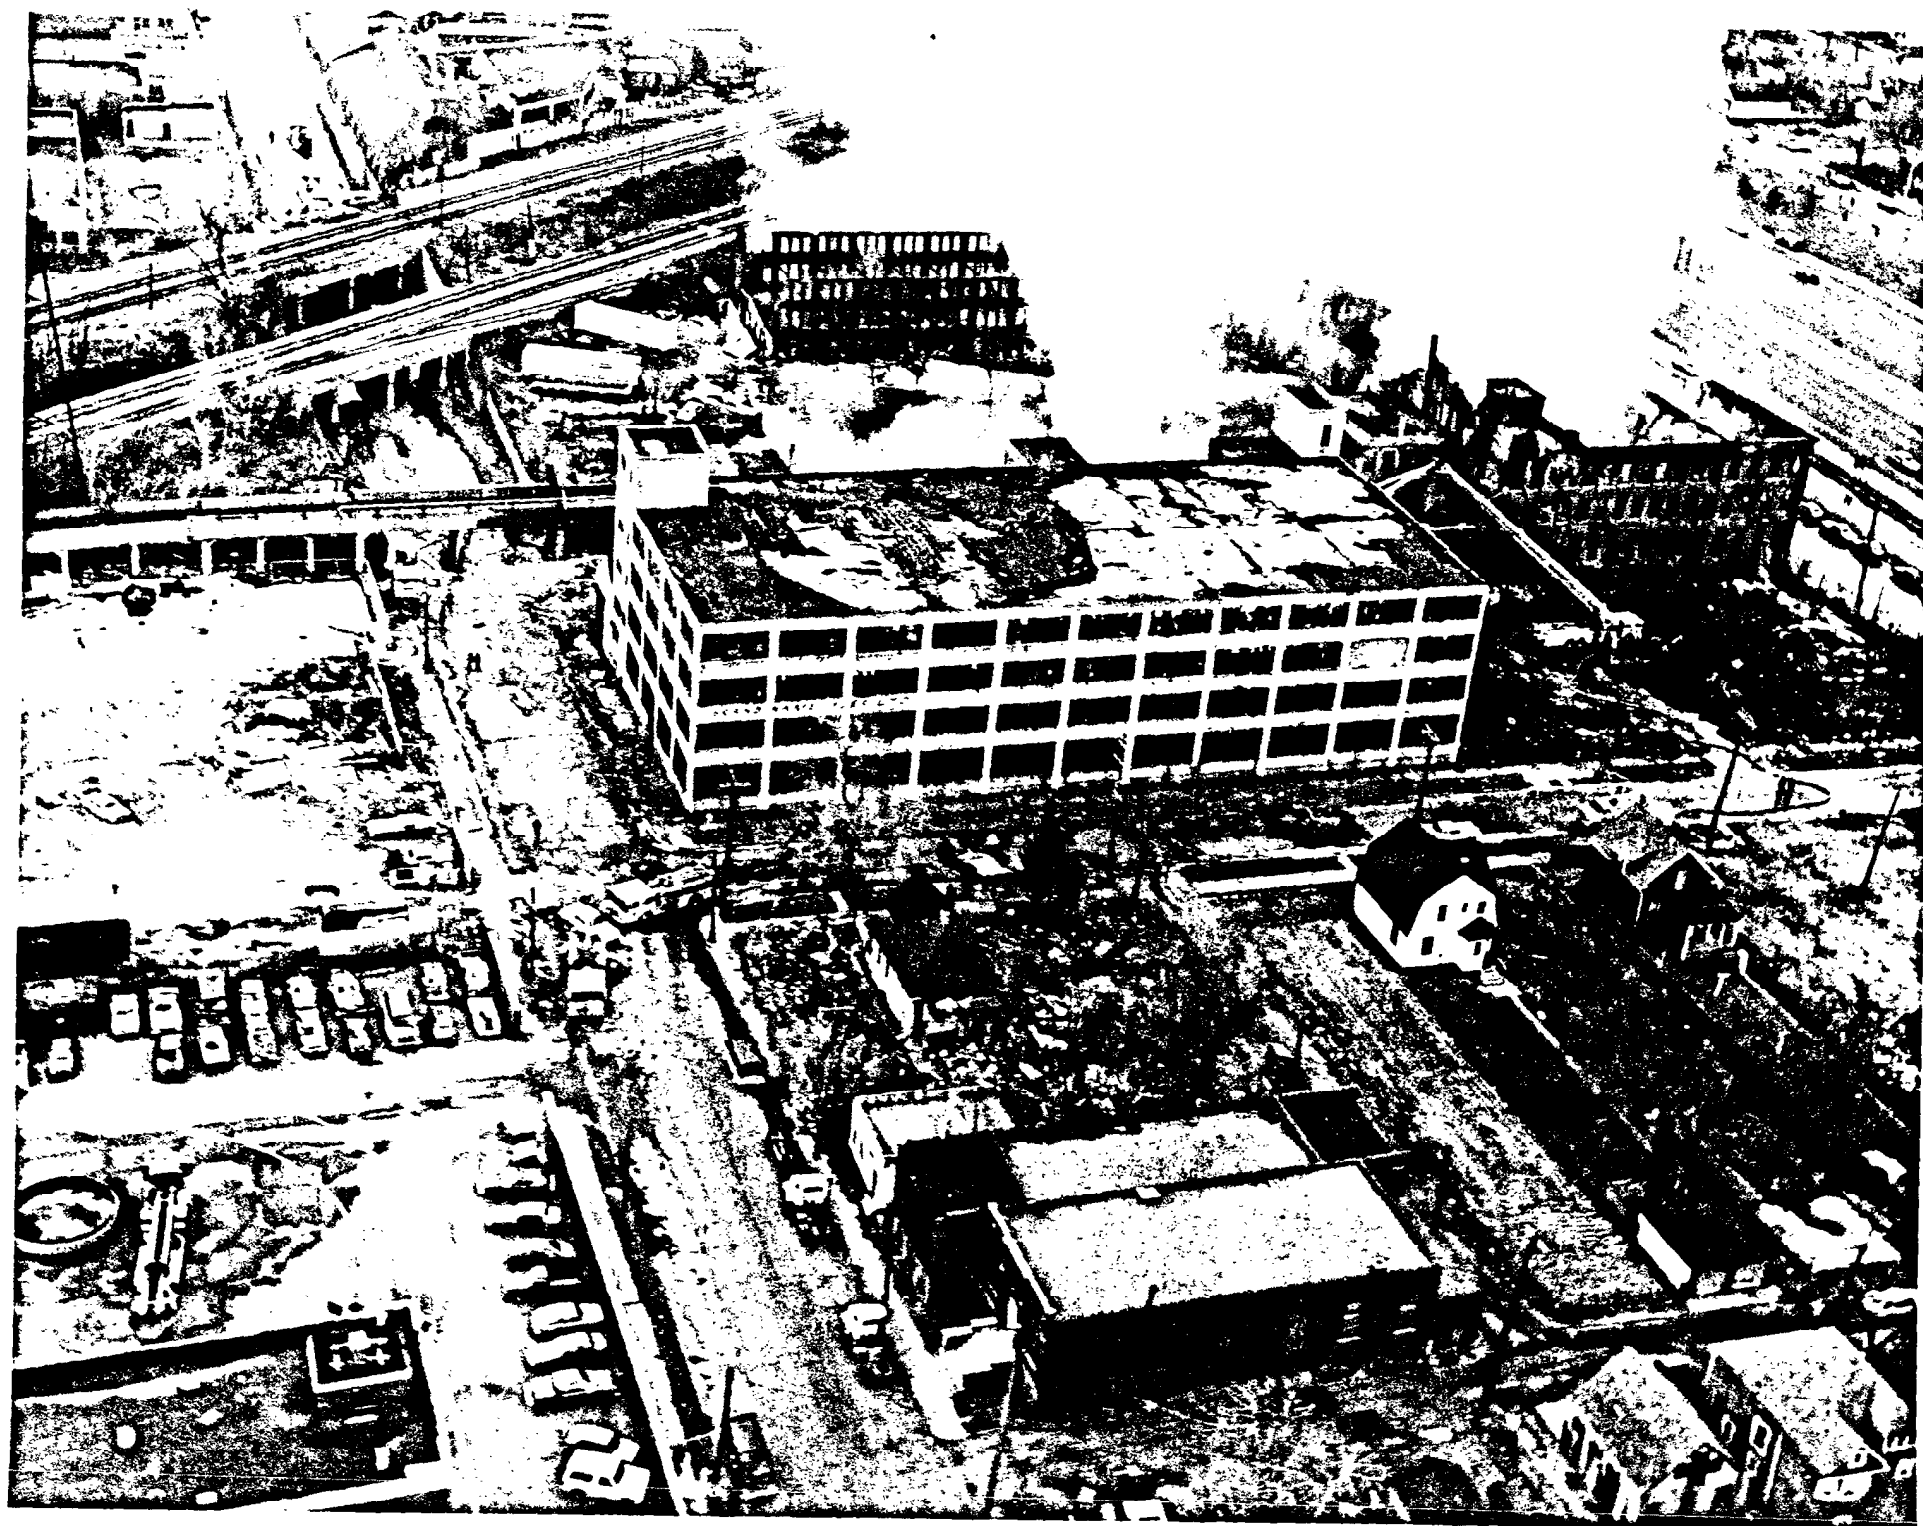
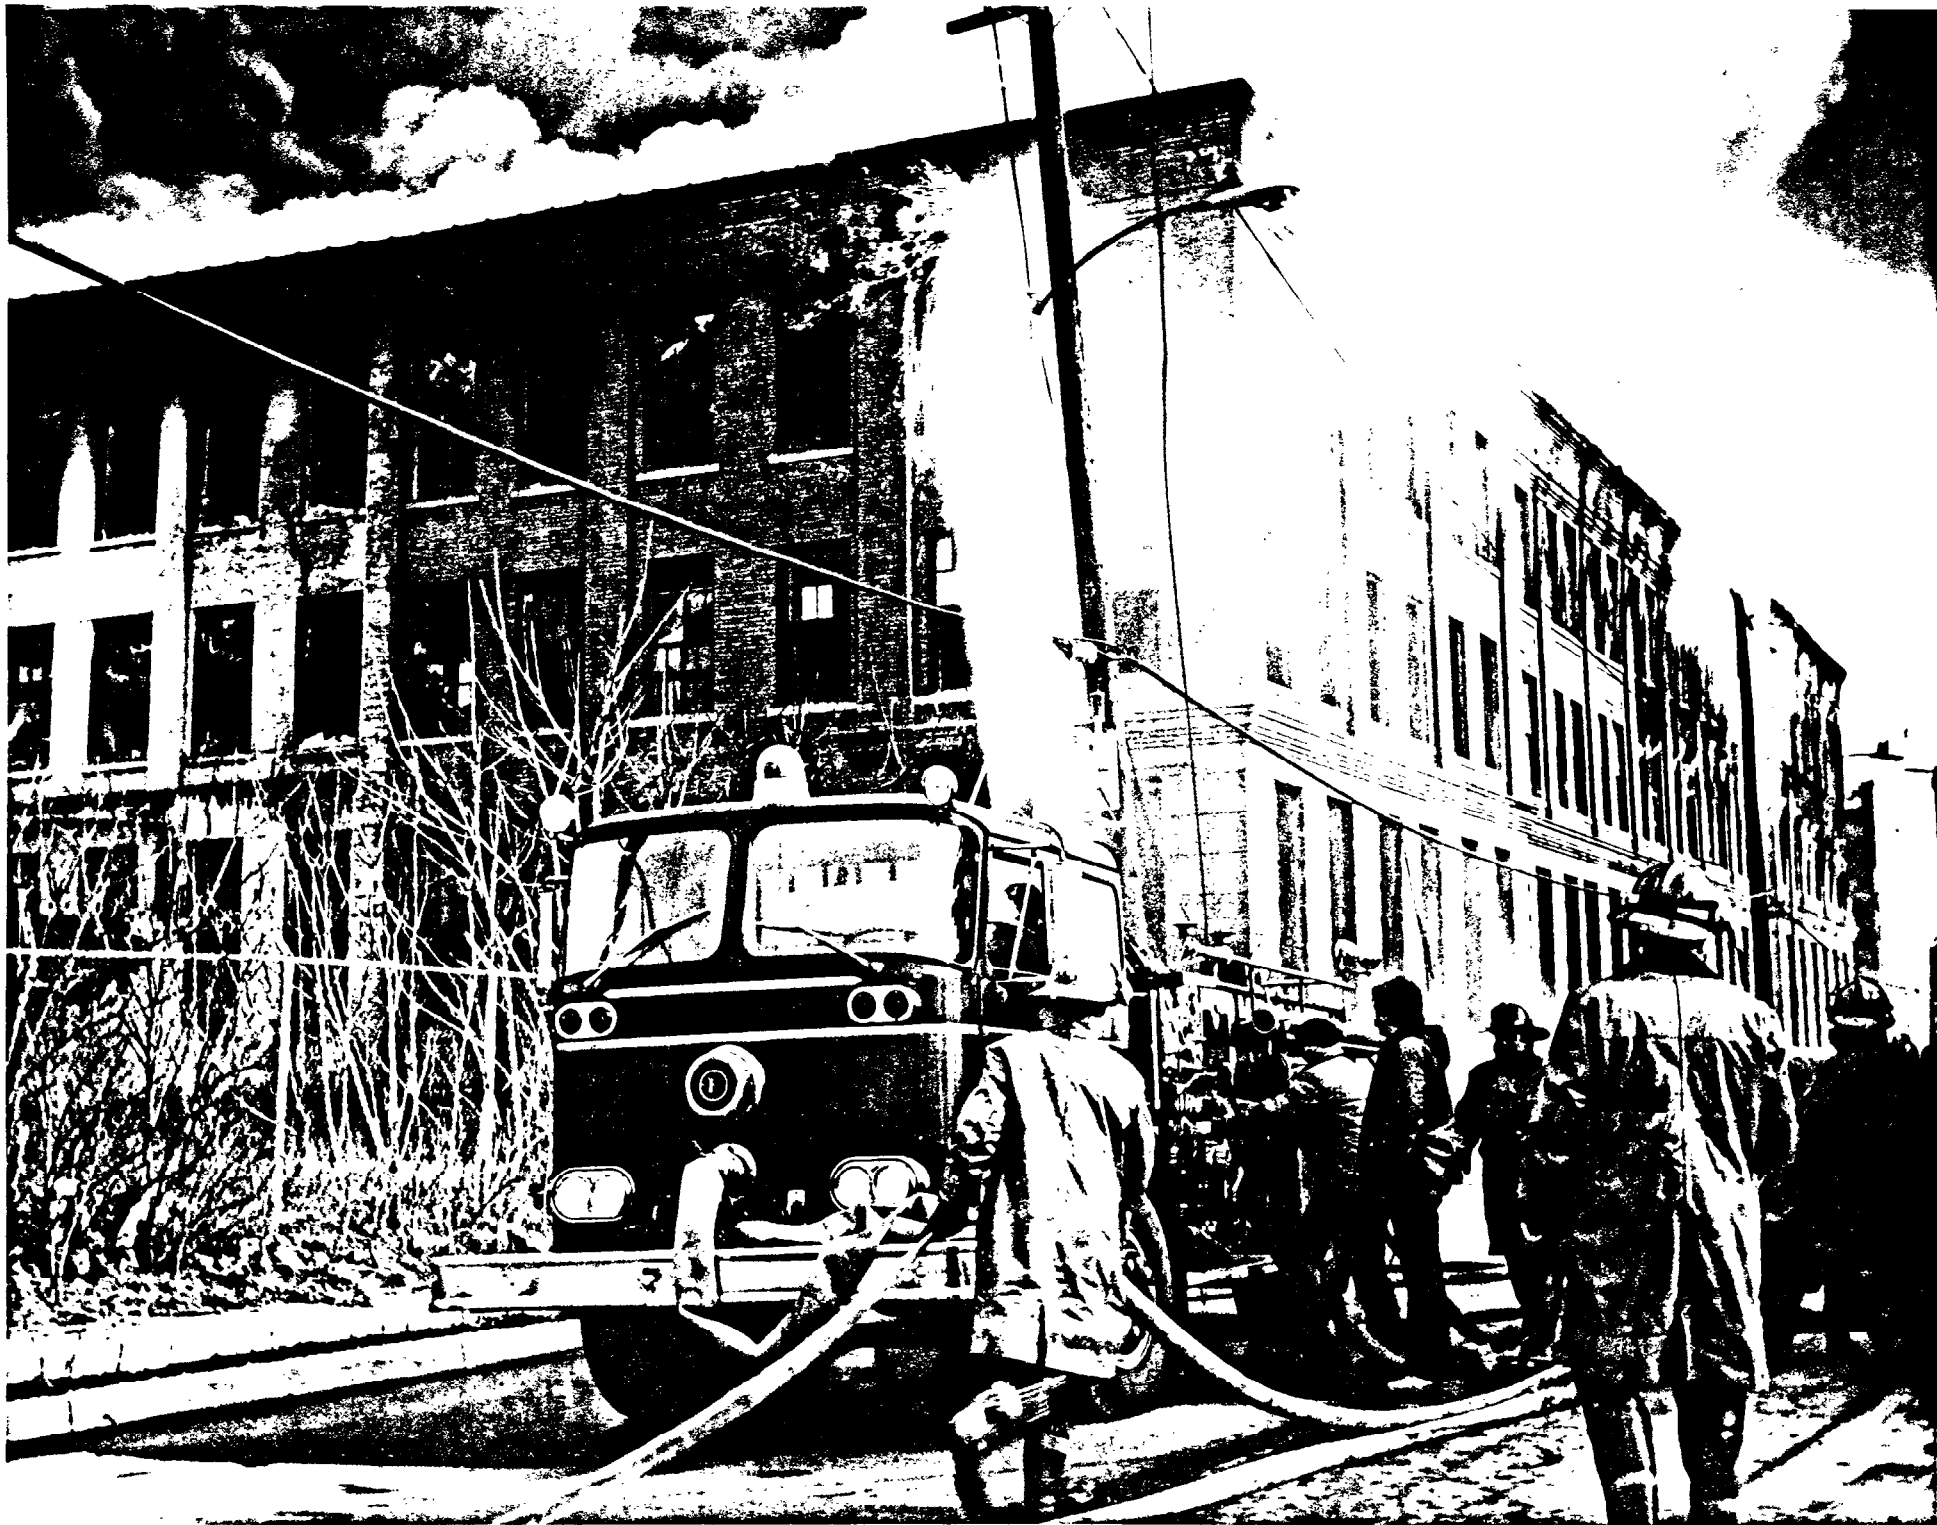
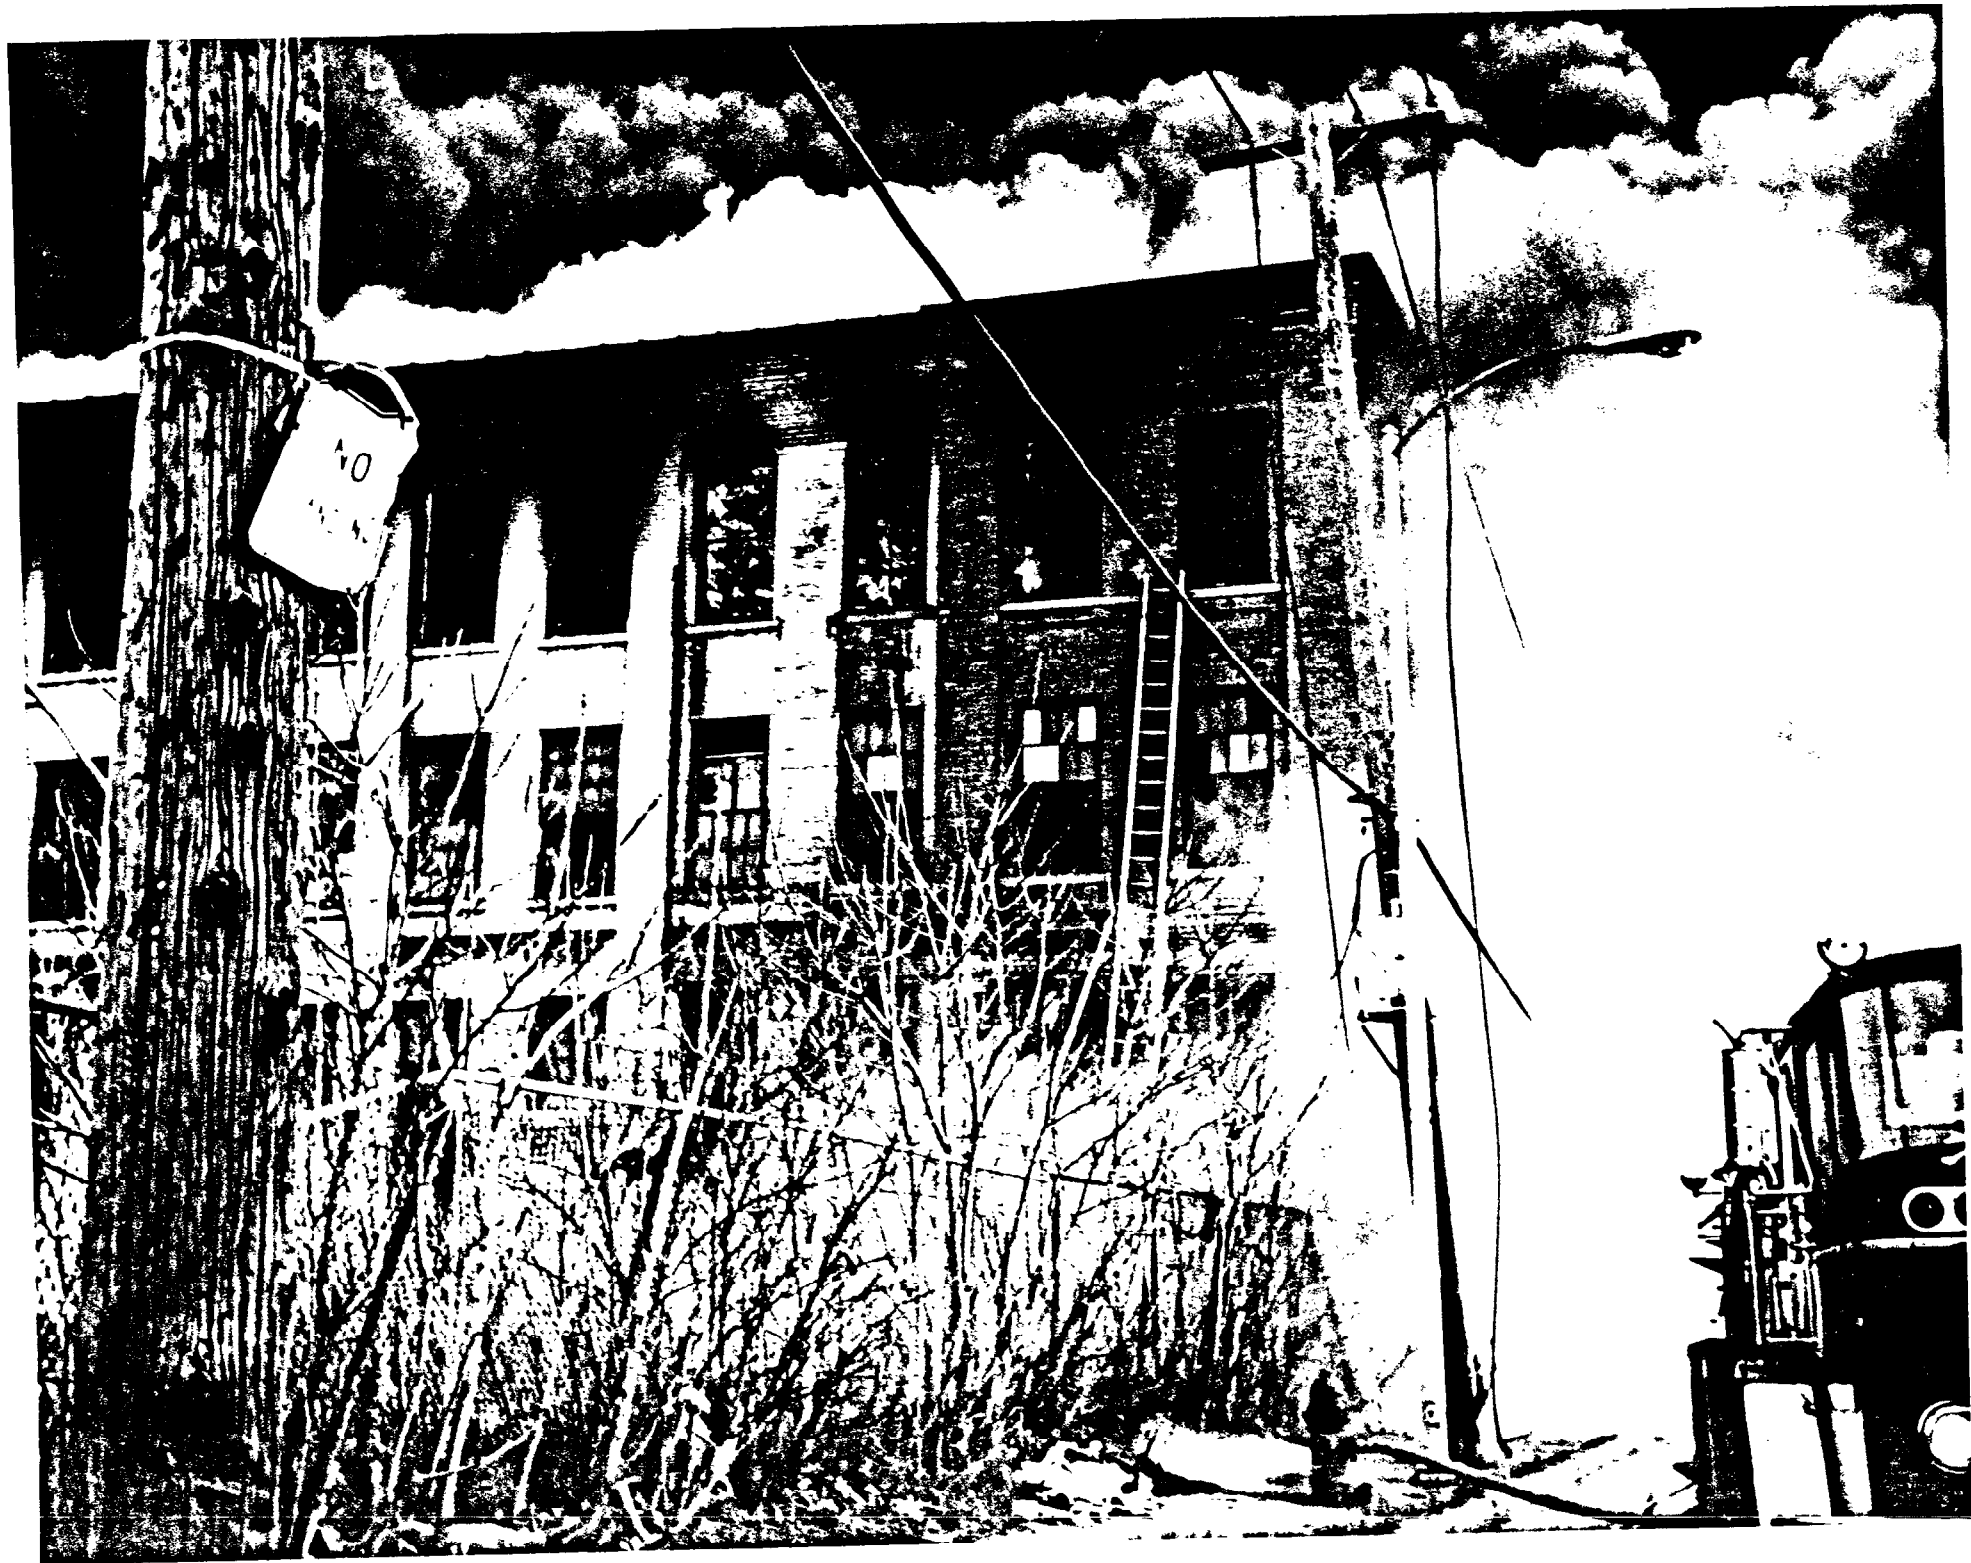
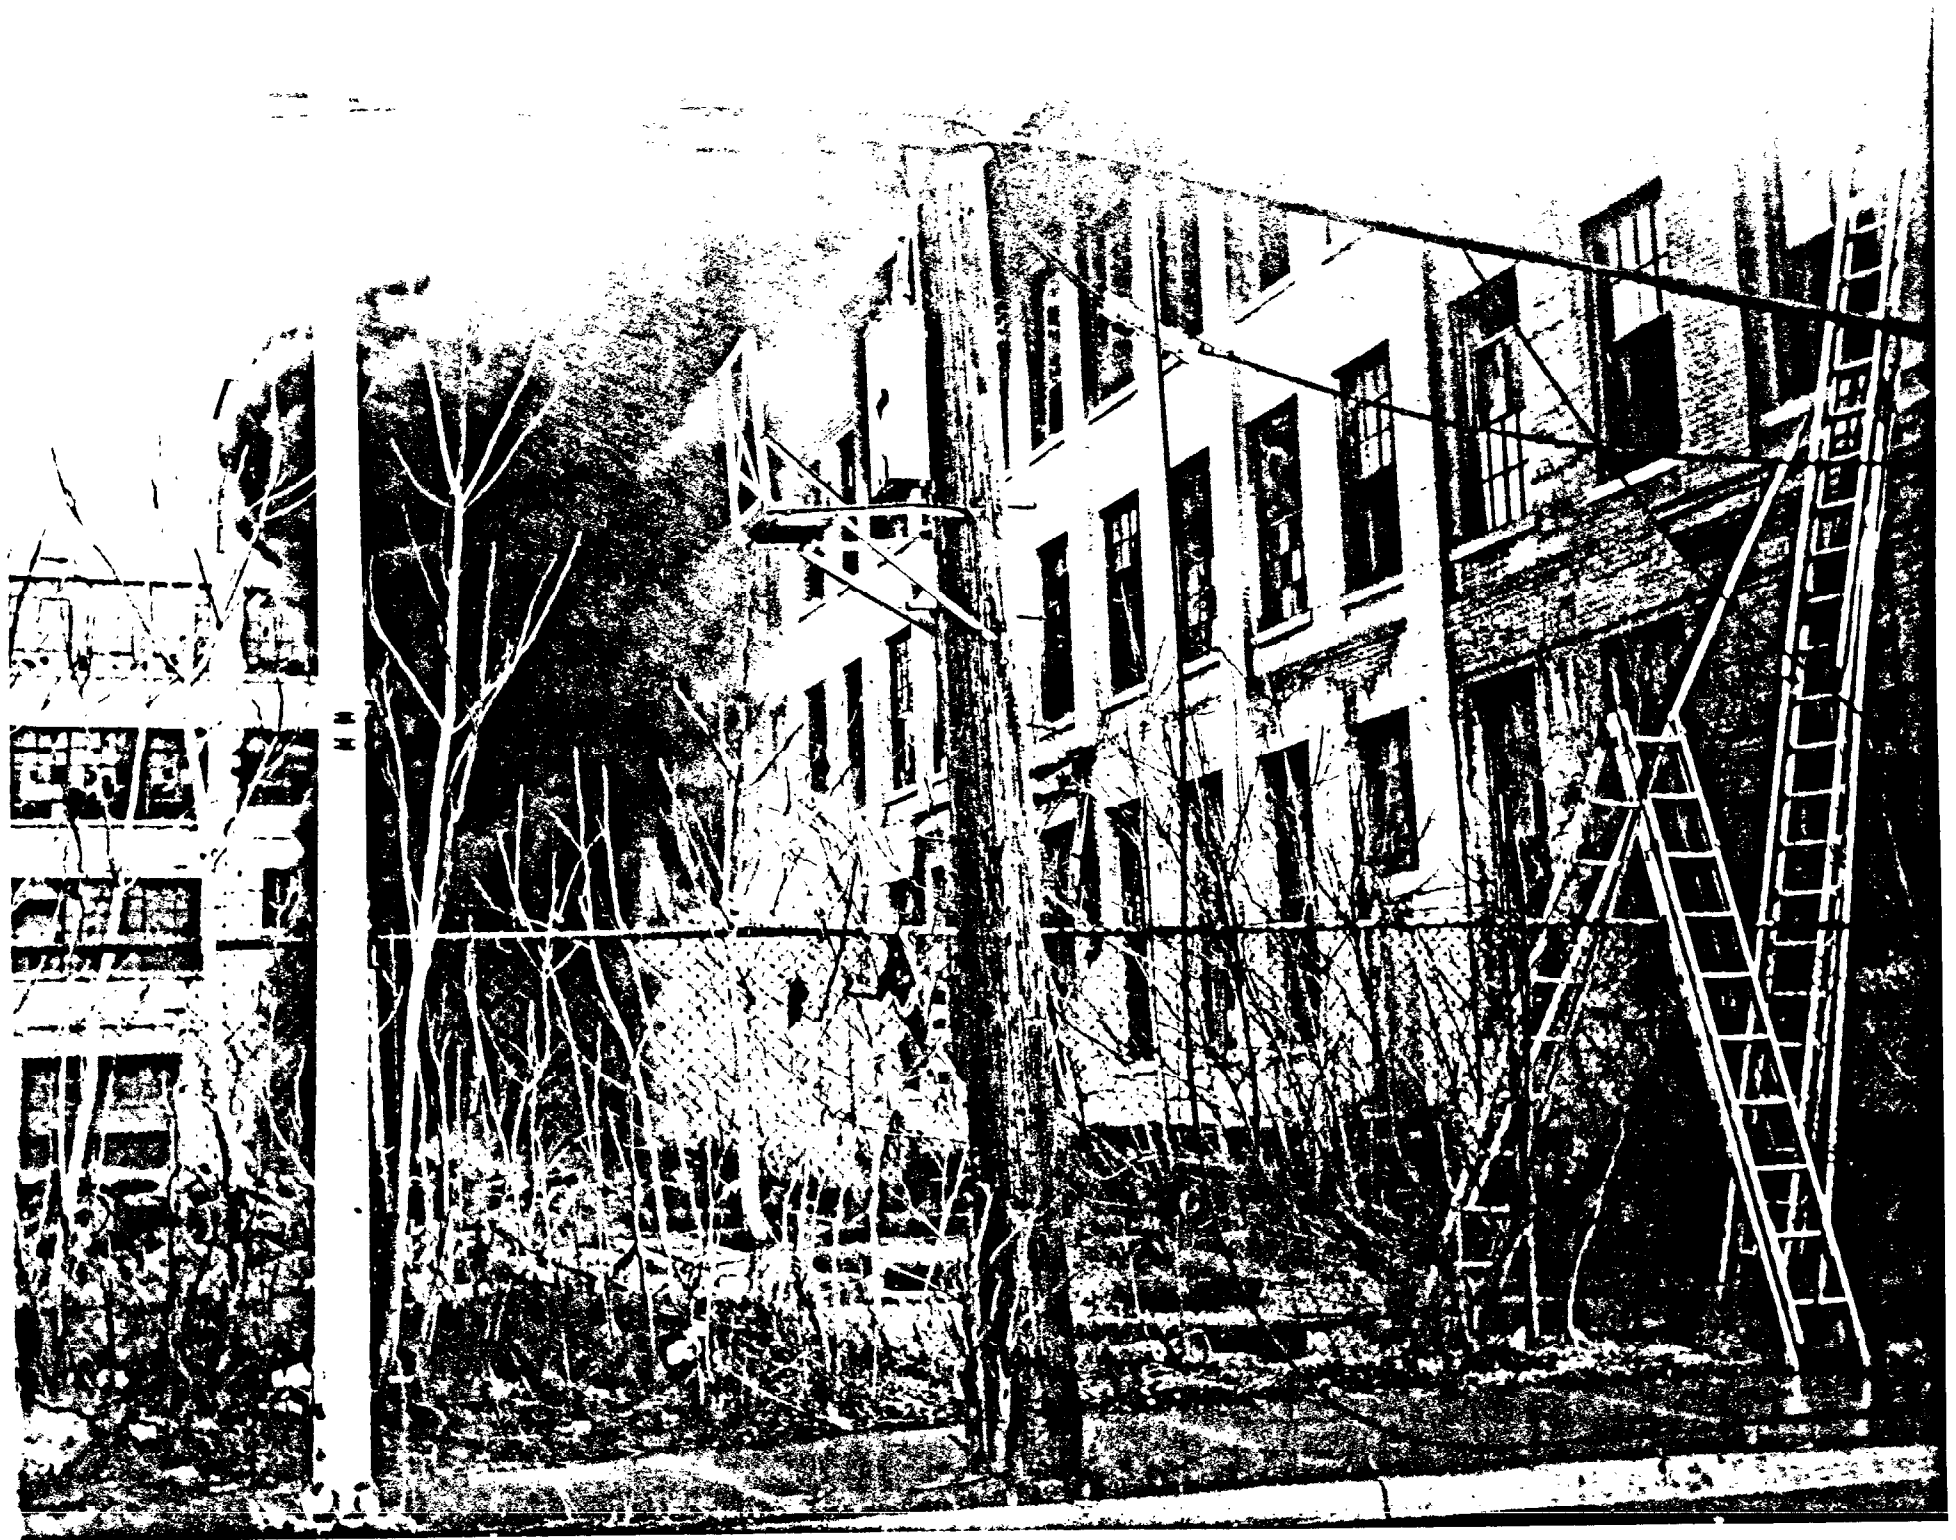
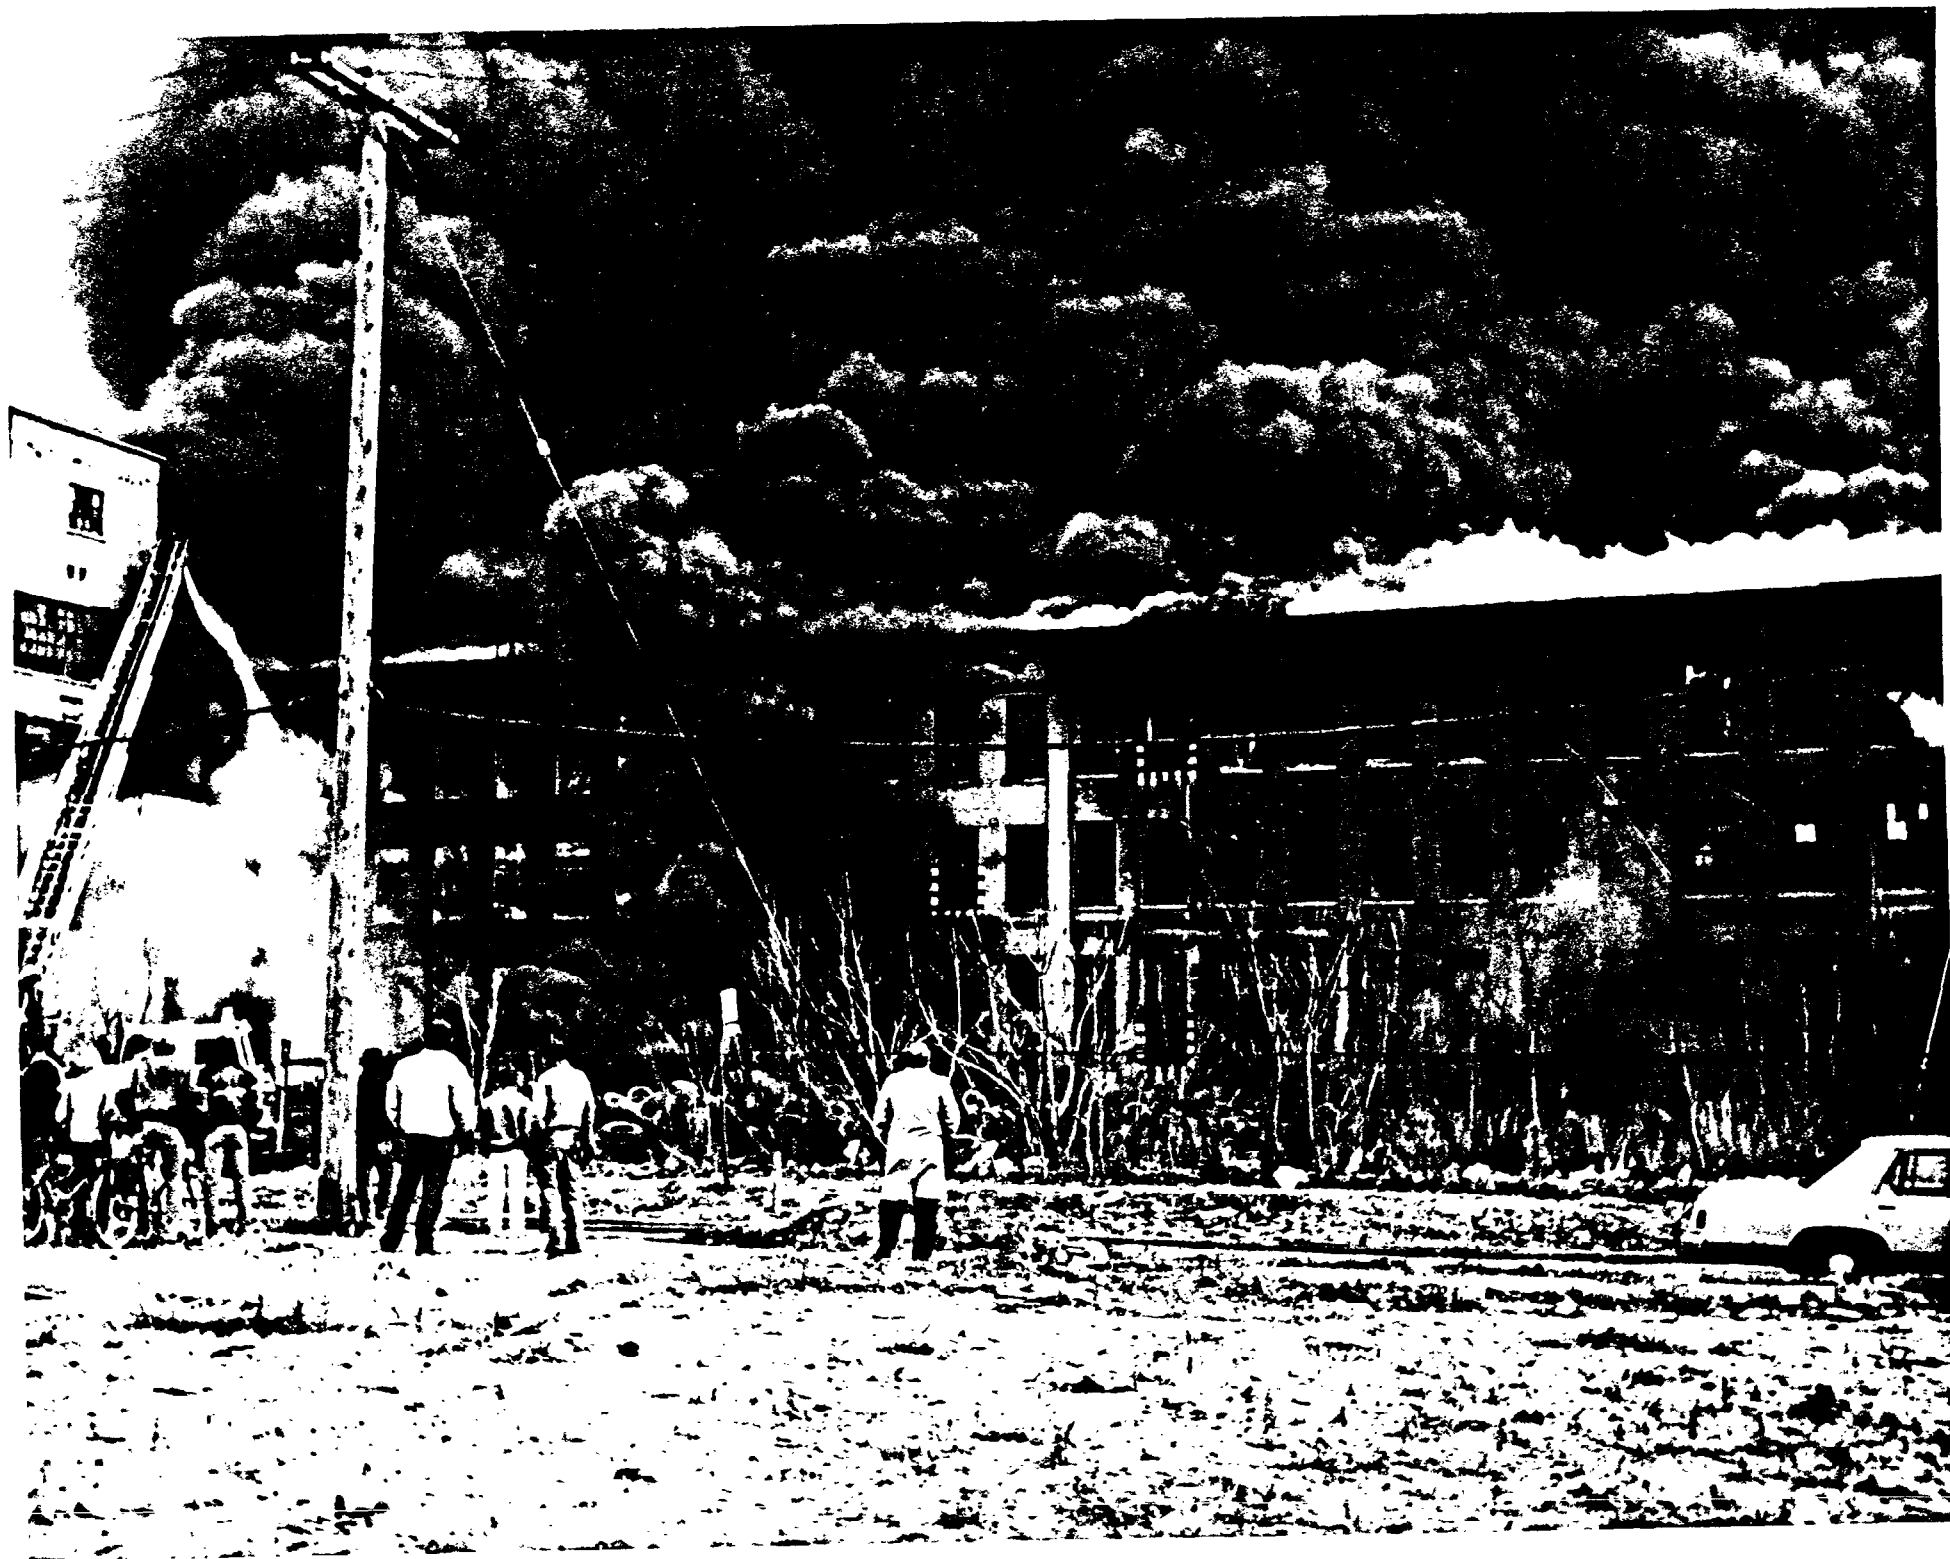
Photos 8-12

Continuing fire fighting activity,, Northwest part of complex.
